Kirby Morgan Dive Systems, Inc.®

Bulletin #5 of 2007. June 12, 2007

Microphones Now Shipping With Strain Relief Ring & Equalizing Vent

Products Affected: 515-022, 515-029, 315-201, 515-023, 515-033, 515-009, 315-206, 315-017, 515-024 and 515-030.

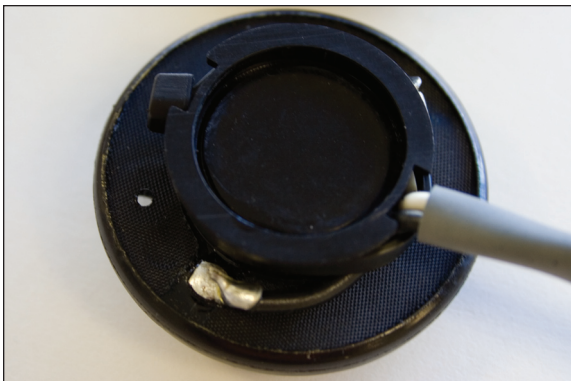
Kit Assembly

The strain relief will provide needed support for the wire connection. It was found that frequent removal of the microphones from the oral nasal could cause stress to the wires where they attach and cause the solder joint to fail.

The protective membrane at the back side of the speaker, was in some cases, too slow to respond to changes in pressure. This caused the speaking diaphragm to either collapse partially or completely. This would diminish or destroy the diaphragms functioning. The addition of a small vent hole will prevent this from occurring.

- 1) The addition of a strain relief ring attached to the back side. The strain relief is not available as a spare part.
- 2) The addition of a small equalizing vent on the back side.
