**Safety Notice 1 of 1999:
SuperLite 17 A/B Neck Clamp 11 May, 1999**

Subject:
Weld Strength

Product Affected:
**SuperLite 17 A/B
Neck Clamp Assembly**

manufactured from 10/97 to 12/98

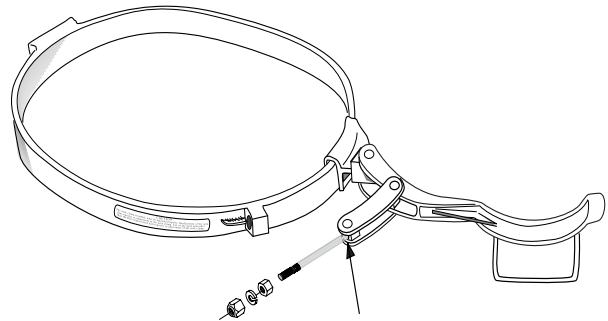
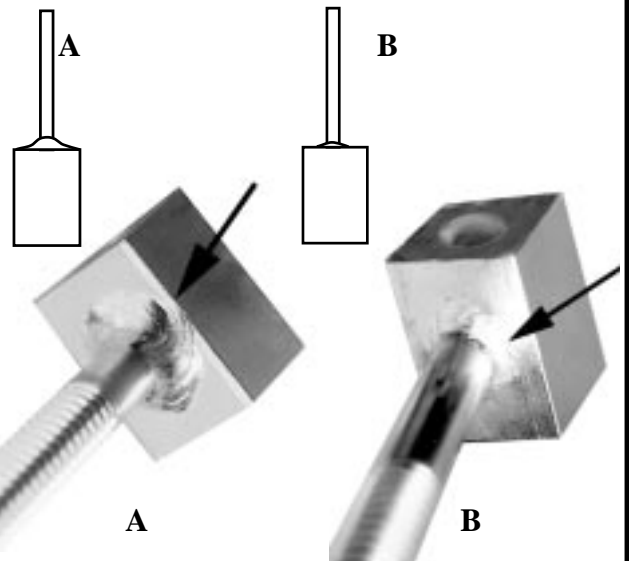
This weld should have 1/8" of material (1/8" fillet weld) all around the stud as shown in figure A. If your clamp has a weld like the one shown in figure B, (no extra material) please return it to your nearest Authorized DSI dealer immediately for inspection and replacement if necessary. For close up color images of the welds, see the **notices** section of our web site at www.Diving Systems.com

NOTE: The potential of possible failure of the weld shown in figure B increases when the users neck clamp is not properly adjusted. If you use any neck seal other than the standard DSI neck dams,

Inspect your neck clamp immediately.

YOU MUST RE-ADJUST YOUR NECK CLAMP ASSEMBLY FOR PROPER OPERATION!

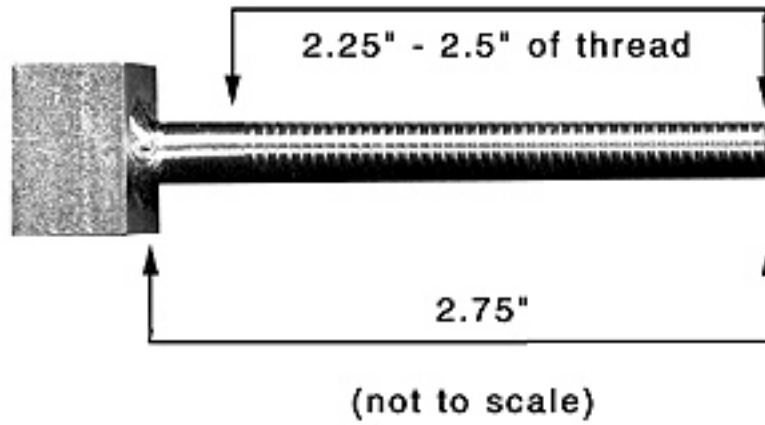
This is the exact dimension of the stud that will help identify warranty replacement.
Anything other than this will not qualify under the safety notice.
